Report on  
Remediation Action Plan

Proposed Industrial Development  
253 - 267 Aldington Road, Kemps Creek, NSW

Prepared for  
RP Infrastructure Pty Ltd

Project 204098.04  
February 2025

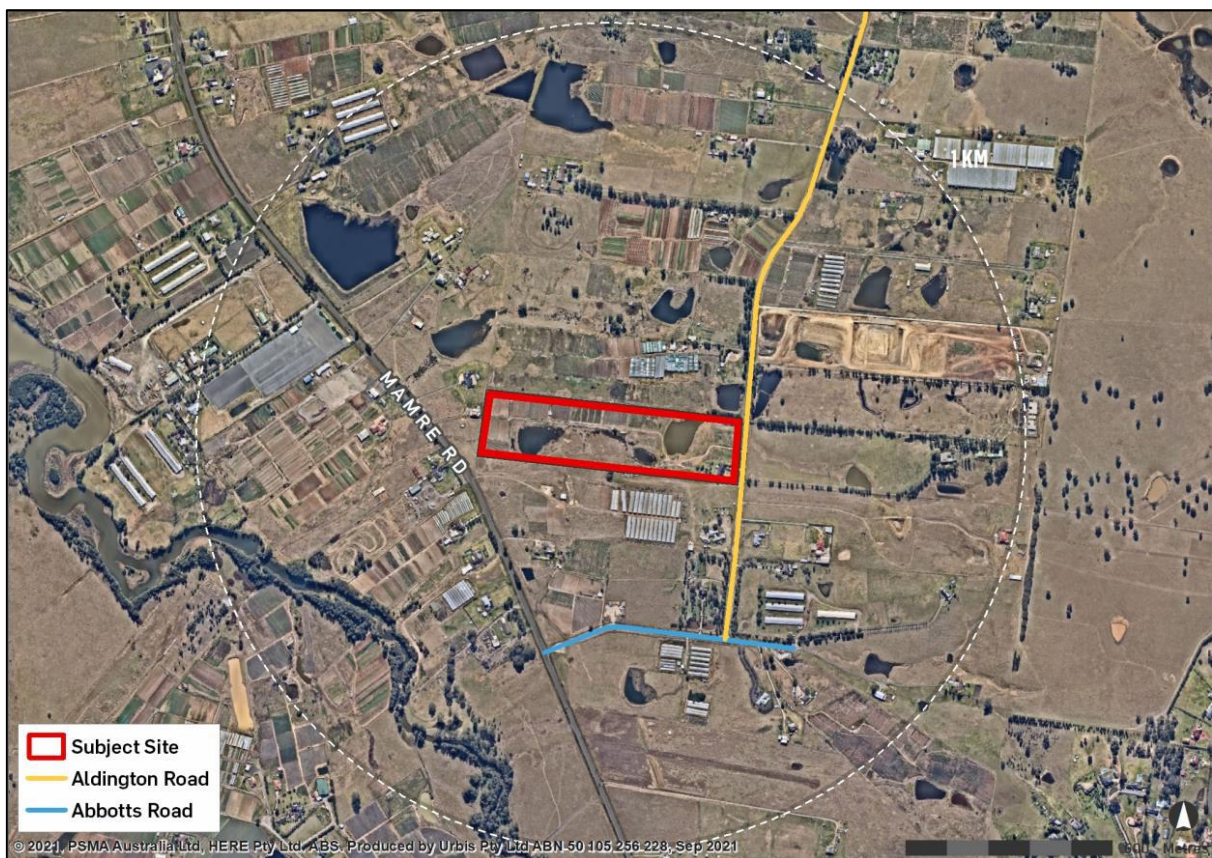
**Figure 1: Site Context**

The site has a primary frontage along its eastern boundary to Aldington Road of 160 m, in which multiple access roads are present, and a depth of 630 m. The site is currently occupied by a dwelling house, sheds, three dams and agricultural land as shown in the aerial photograph in Figure 1 below. Kemps Creek runs within 500 m south west of site before joining South Creek, Mamre Road runs between these creeks and site.

Multiple state significant developments (SSDs) and local development applications (DAs) are currently being progressed for industrial and warehouse development within the Mamre Road Precinct which will substantially change the nature of the surrounding area. The regional context is shown below in Figure 1 (following page).

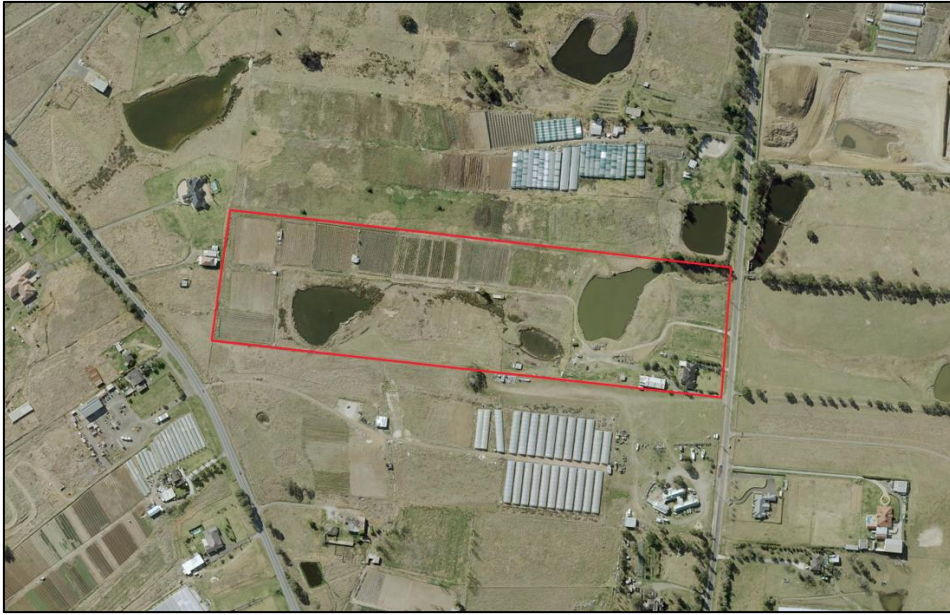
**Figure 2: MetroMap Aerial Imagery Dated 15 August 2021**

- At the time of completing DP (2021), the latest available imagery was dated 15 August 2021, as shown in Figure 2 (following page). The most recent aerial imagery now available is dated 1 August 2023, as shown in Figure 3 (following page), and depicts that the site and its surrounds have remained relatively unchanged since the issue of DP (2021), with the exception of the following observations from the surroundings of the site:
- Greenhouses associated with market garden activities were removed from the land located north of the site;
- Additional greenhouses are visible south of the site; and
- Continuing of bulk earthworks, including the construction of new roads are visible northeast of the site.

*Site boundary is denoted by the red outline.*

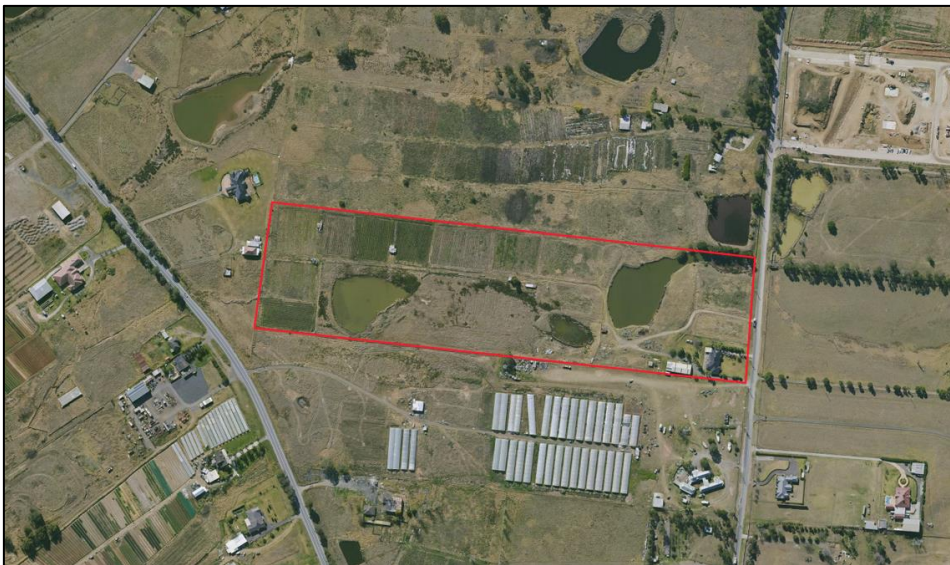
**Figure 3: MetroMap Aerial Imagery Dated 1 August 2023**

*Site boundary is denoted by the red outline.*
